**Subject:** Preliminary Contamination Assessment at 2 Bachell Avenue, Lidcombe NSW

Sullivan Environmental Sciences Pty Ltd (Sullivan-ES) was engaged by Hallmark Construction Pty Ltd to conduct a Preliminary Contamination Assessment at 2 Bachell Avenue, Lidcombe NSW (the site).

**Figure 2:** Site Layout  
and Sample Locations

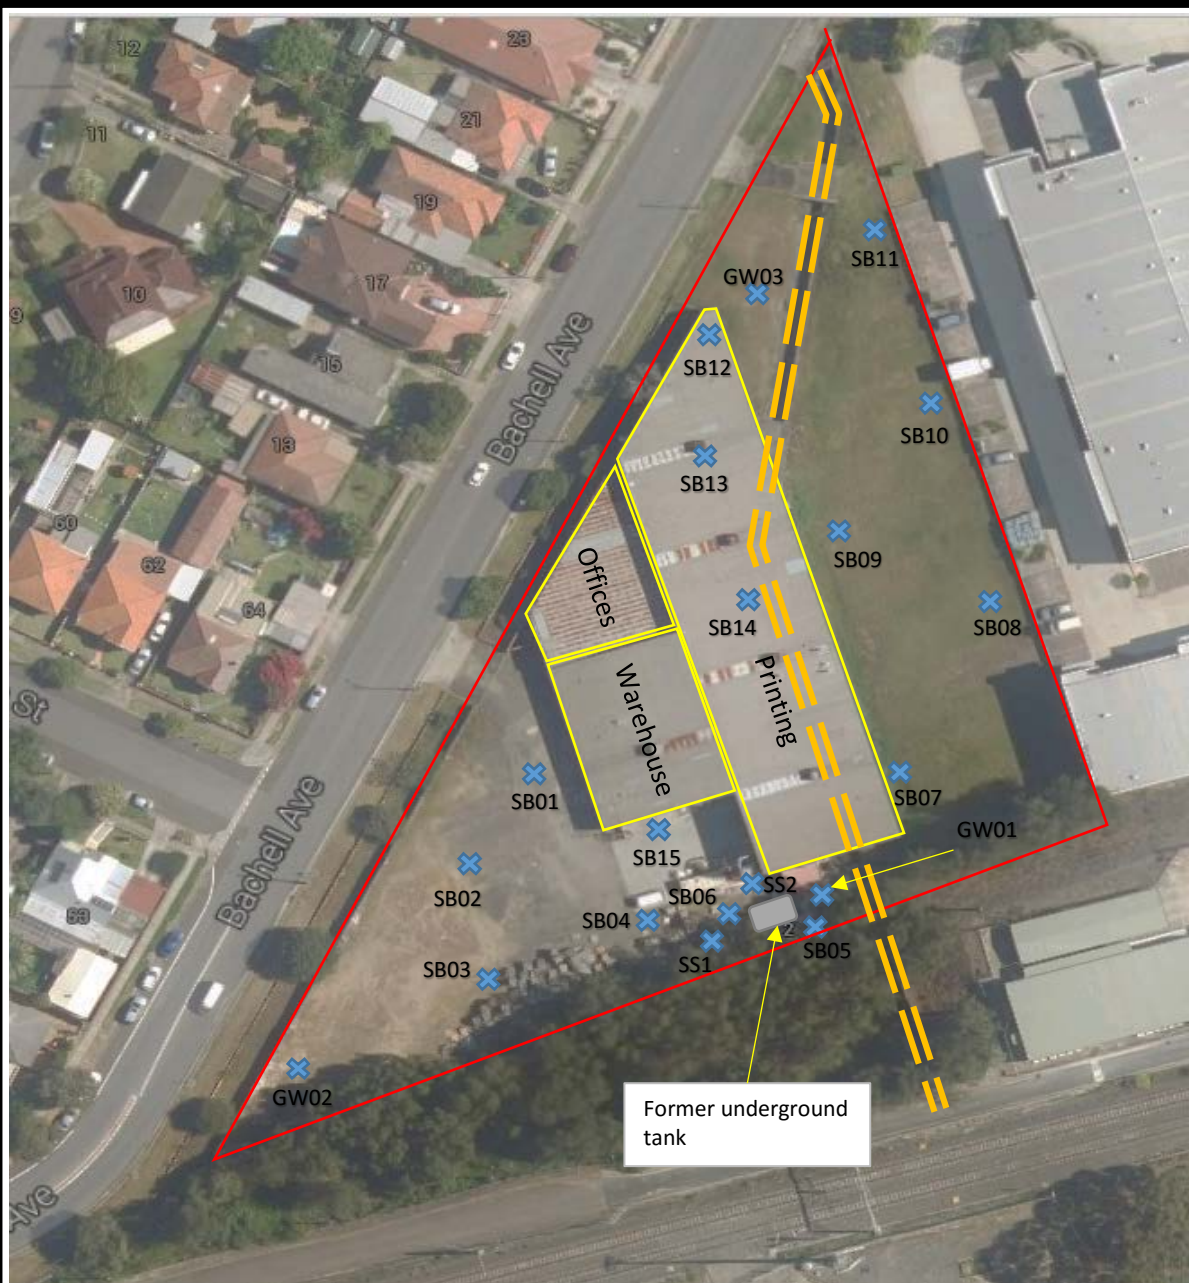
The scope of work included drilling and sampling of soil at 20 borehole locations, sampling of 3 groundwater wells, chemical analysis for a suite of contaminants at a NATA accredited laboratory, and preparation of a Phase 2 report. Analytical results were compared to relevant soil and groundwater criteria for high-density residential land use. A copy of the Phase 2 sampling locations and results summary tables are presented in **Attachment A**.

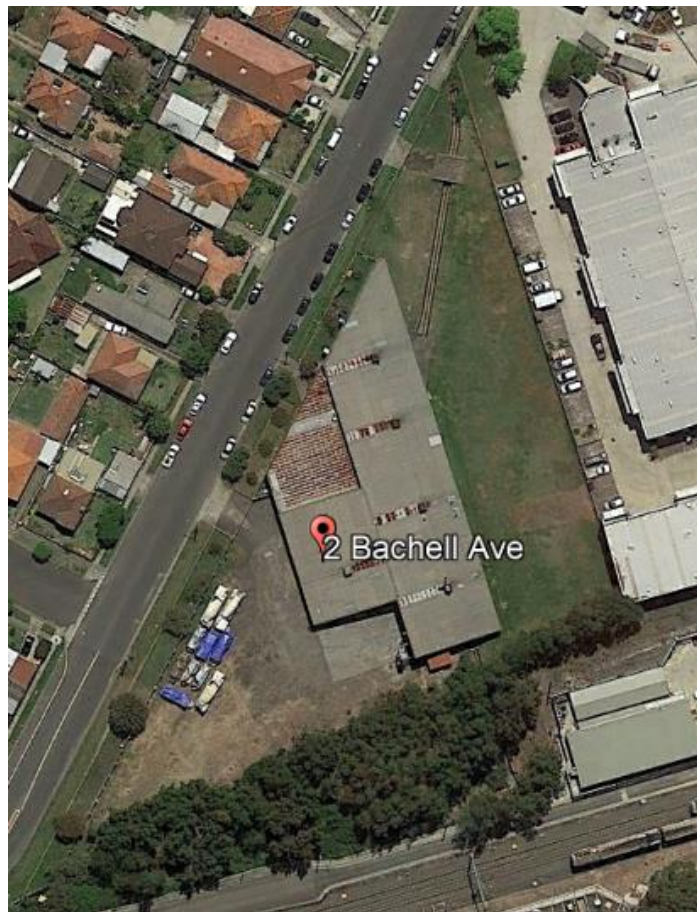
| Month/Year | Details |
|---|---|
| Oct 2015 | This image shows the site at the approximate time of the Phase 2 investigation. The western side of the building was being used as temporary storage of heavy vehicles (concrete trucks). The eastern side of the building was grassed, vacant and unused. |

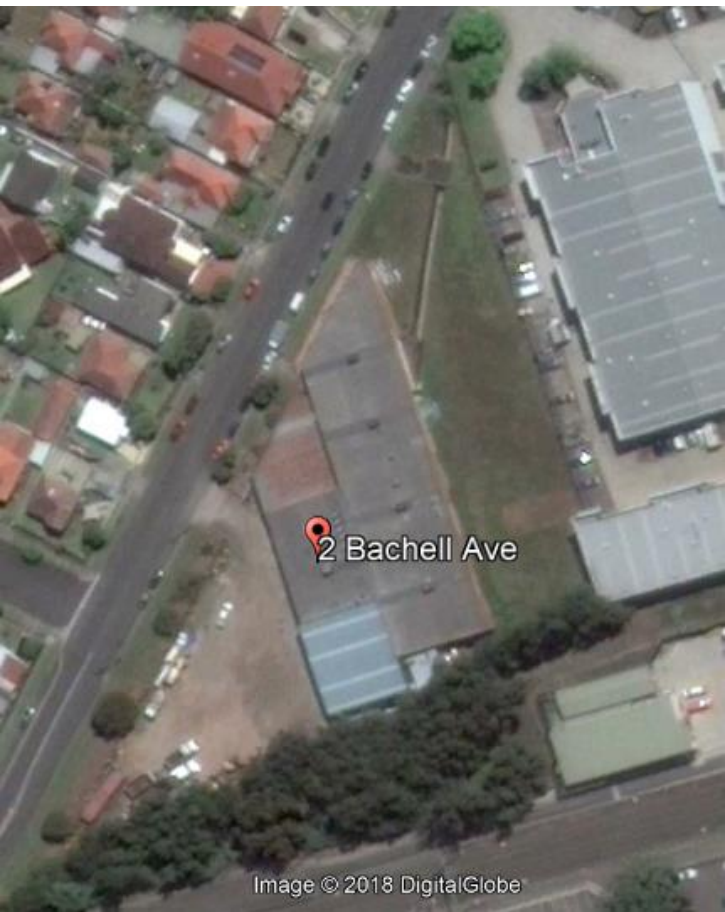
| Month/Year | Details |
|---|---|
| Oct 2016 | <p>At this time the laundromat business is operating within the building and a roof has been constructed over the southwest portion of the building to cover LPG tanks and external equipment.</p> <p>The western side of the building is sparingly being used for storage of materials by the lessee.</p> <p>The eastern side of the building remains grassed, vacant and unused.</p> |

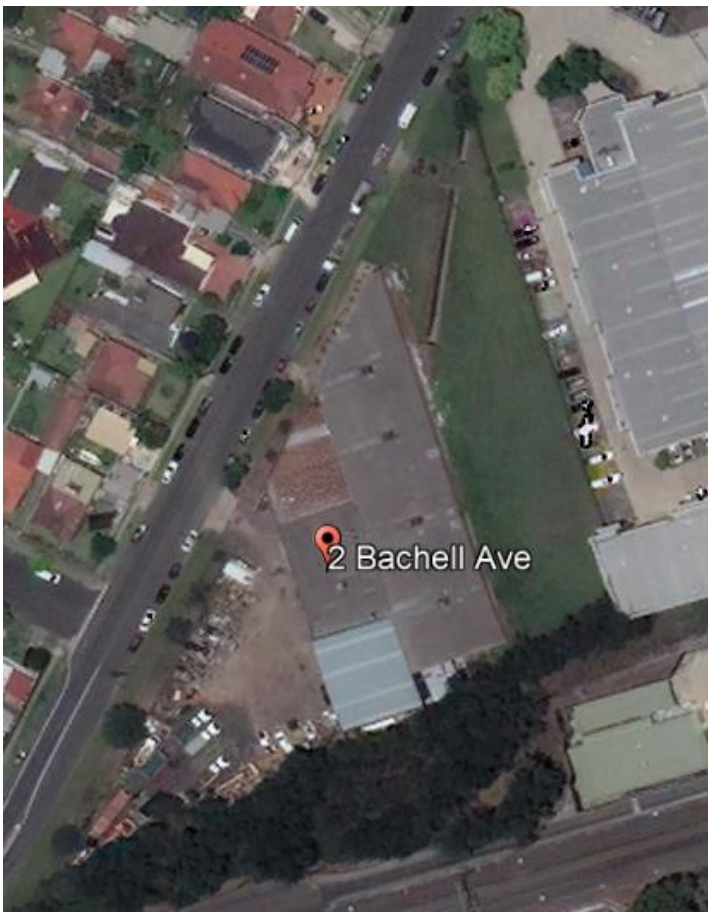
| Month/Year | Details |
|---|---|
| Dec 2017 | No major changes have occurred anywhere onsite other than greater storage of materials in the western lease area. |

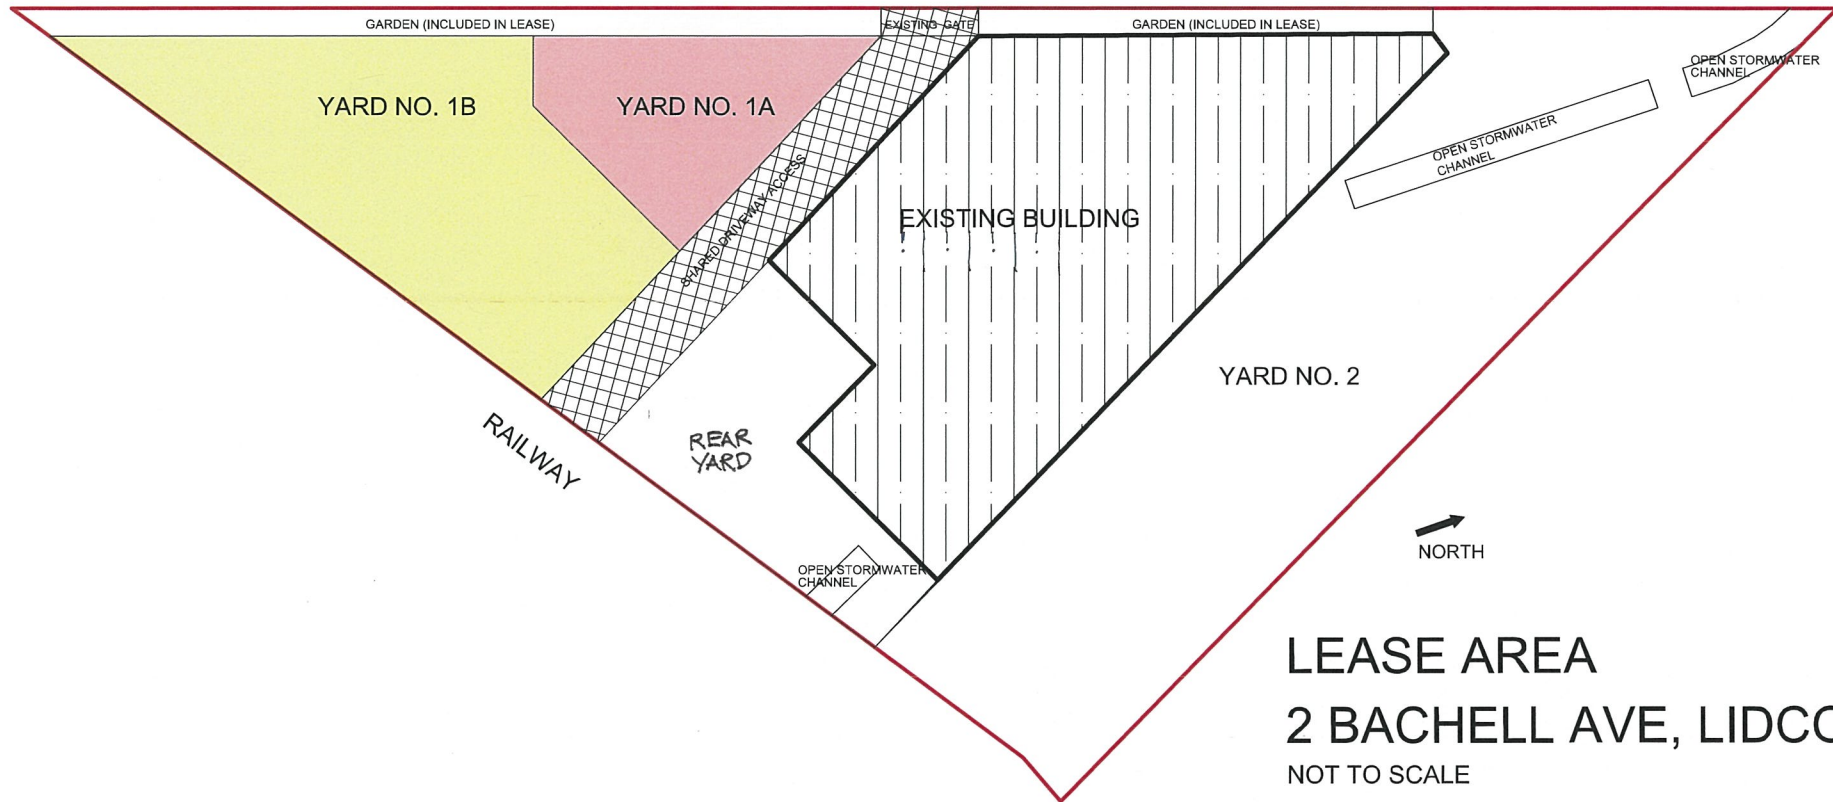
Tenancy Map

Tenancy records were provided by Hallmark as information relevant to site activities since the time of the Phase 2 (2016). Refer to the annotated figure presented in **Attachment C** for reference to site areas. The following information was obtained.

| Site Area | Time Period | Tenant Activity |
|---|---|---|
| Yard 1A | Oct 2015 - March 2016 | Storage of earthmoving machinery and hire equipment. |
| | Mar 2016 - present | Storage of earthmoving machinery (same tenant as Yard 1B). |
| Yard 1B | Nov 2015 - present | Storage of earthmoving machinery. |
| Building and rear yard | Apr 2016 - present | Commercial laundromat and dry-cleaning business (Excellent Laundry). |
| Yard 2 | Oct 2015 - present | Vacant and unused (temporary storage of construction equipment at north end). |

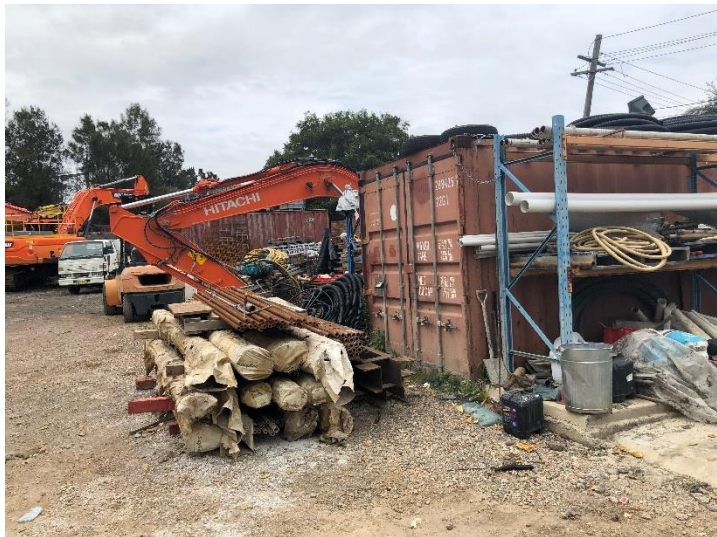
- Unsealed gravel surfaces. No oil stains or surface blemishes were observed.
- Heavy machinery storage, earthmoving equipment (25T excavators), related materials storage.
- No fibro cement materials or waste (potentially containing asbestos) was observed.
- Shipping containers, steel frames/scaffold, storage cages.
- Truck trailers, forklift, tip trucks, vehicle body parts.

Yard 1A stored items and ground cover.

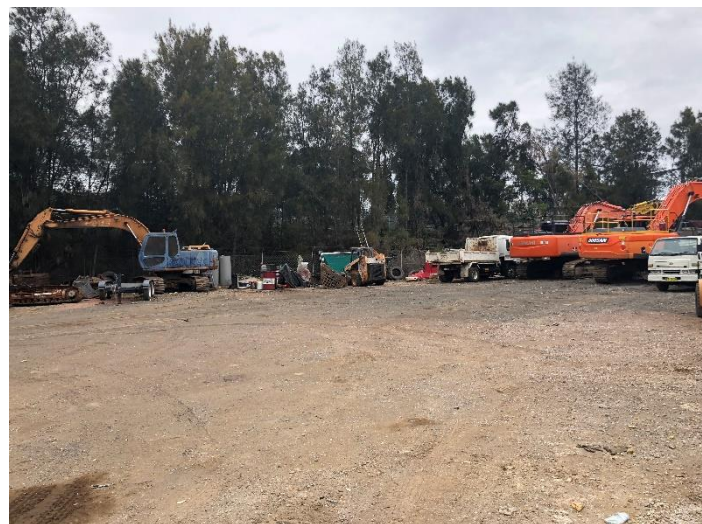
Yard 1B stored items and ground cover.

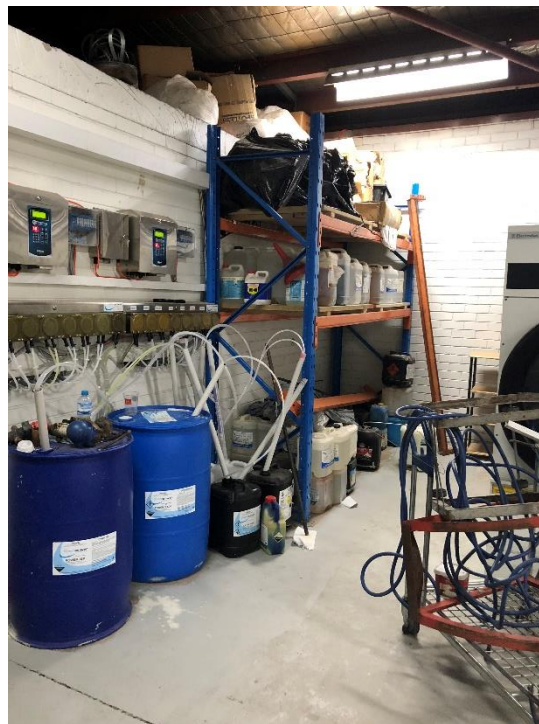
Insufficient information was obtained with respect to chemical use for the laundromat/dry-cleaning business. The following information remains outstanding:

- Inventory and Safety Data Sheets (SDS) for all chemicals used in the laundromat operations.
- Lists of chemicals previously used onsite.
- Permit/licence for chemical/dangerous goods storage.
- Quantities of chemicals stored on the site.
- Spill incidents records.
- Spill management/prevention procedures.
- Emergency spill containment procedures.
- Wastewater treatment/quality and discharge details.

Chemical store within laundromat business.

- While commercial laundry/dry-cleaning activities have not been conducted at the site for any great length in time (i.e. approx. 2<sup>1</sup>/<sub>2</sub> years), the operations are considered a high-risk activity under the SEPP55 Planning Guidelines<sup>1</sup>. As such, the information gaps identified in this assessment relating to chemical use should be filled; and depending on the detail of this information, a limited program of soil sampling targeted at chemical stores and general site groundwater may be warranted.

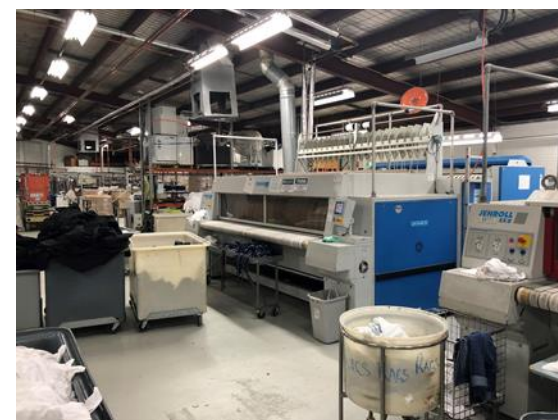
- All operations were located on sealed concrete. Interior concrete floors were painted. No surface stains/spills were observed.
- Interior of building comprised:
  - o Office space
  - o Dry cleaning units in north end of building
  - o Washing machine units
  - o Large washing unit
  - o Ironing machines
  - o Chemicals store on racks and on concrete ground. No bunding was observed in this area. Chemicals noted were 200L drums and 25L containers of caustic alkali additives, bleaches, hydrogen peroxide, and solvents and emulsifiers.
  - o Materials handling/storage areas.
- Exterior of building comprised:
  - o Chemicals dosing/dispensing unit.
  - o Trade waste cooling pit and sewage discharge.
  - o Materials handling/storage areas.
  - o LPG tanks (x 4).

Interior of laundromat business.

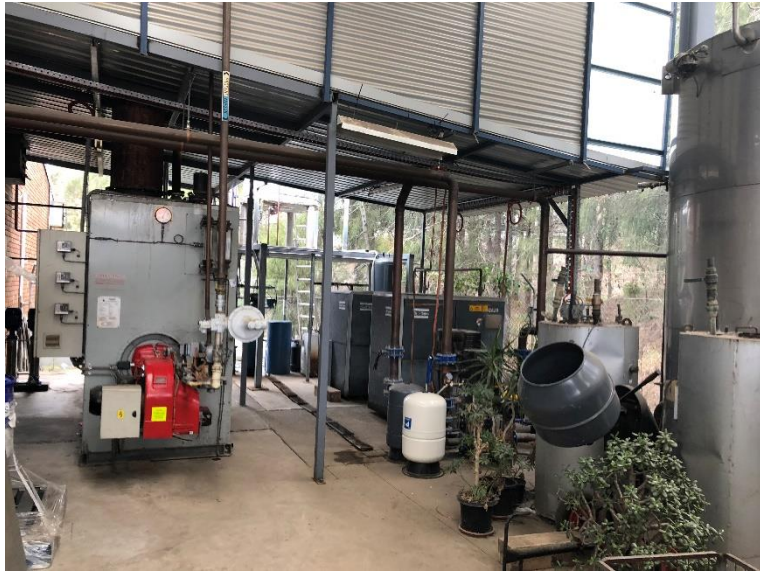
- o Gas-fired boiler.

Exterior of laundromat building – boiler area.

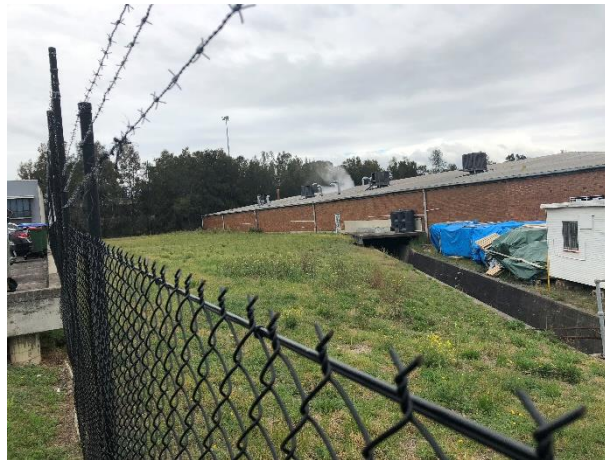
- Larger east side of stormwater channel remains unused/grassed vacant.
- Smaller west side of stormwater channel used to store construction equipment (e.g. site shed/porta-loo, pallets, hoarding material, timbers, temporary fencing, LDPE lining, etc).

Yard 2 vacant land and temporary storage of construction materials.
